**REPAIR OF THE AL GHAZALIYAH
G-7 SEWAGE LIFT STATION**

UNDER THE COMMANDER'S EMERGENCY RESPONSE PROGRAM

BAGHDAD, IRAQ

**SIGIR PA-07-118
JANUARY 25, 2008**

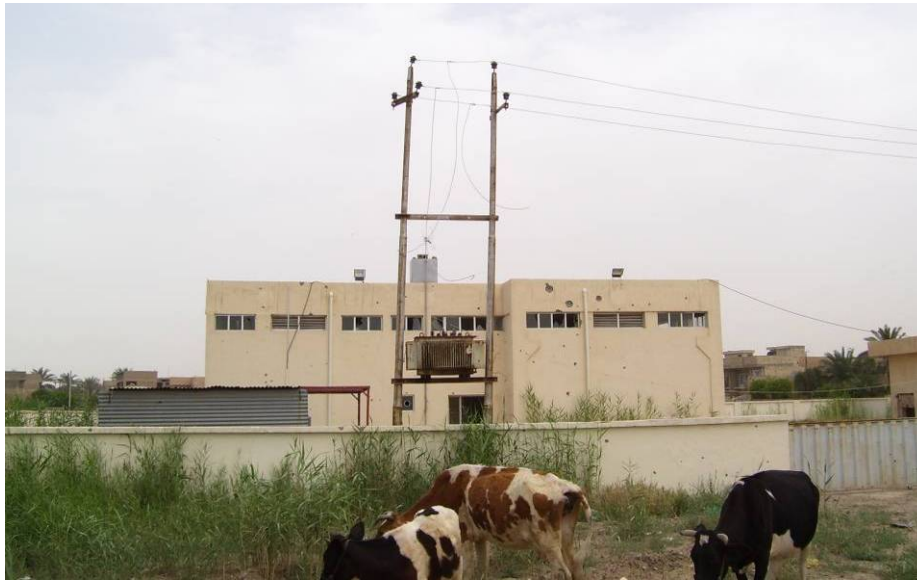
Site Photo 1. Exterior view of the Al Ghazaliyah G-7 Sewage Lift Station

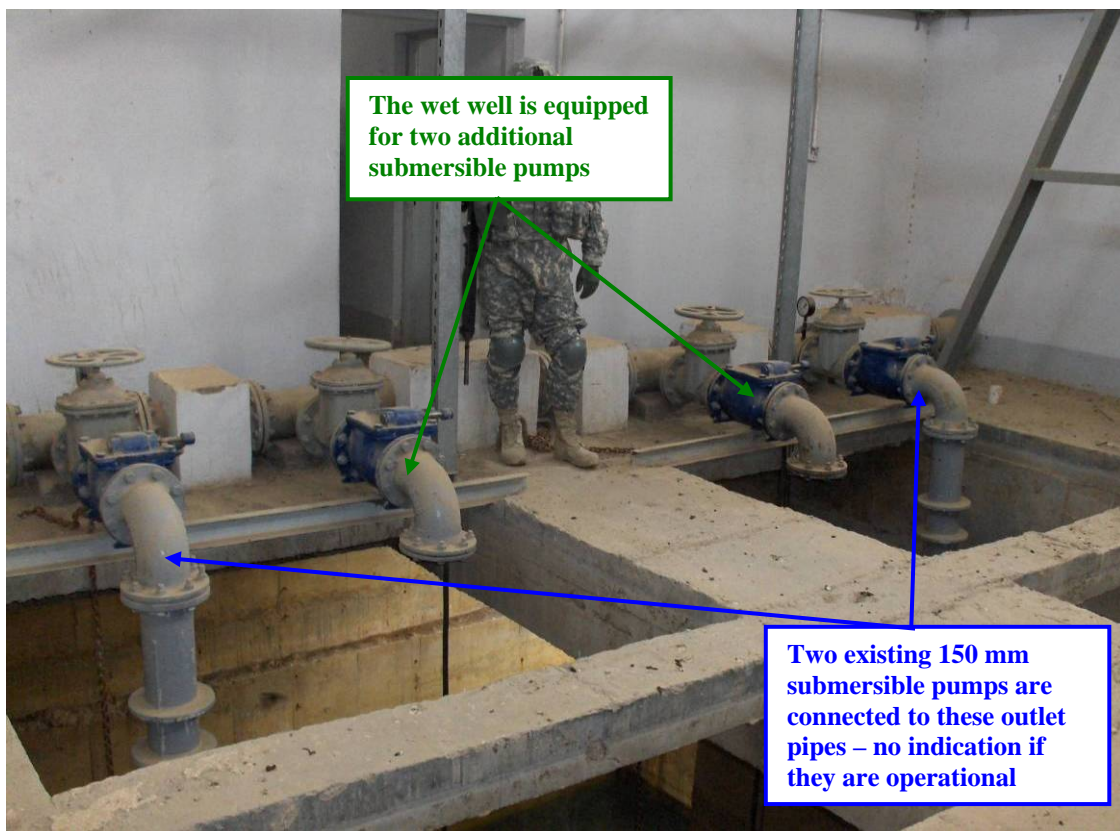
Site Photo 2. Interior view of Al Ghazaliyah G-7 Sewage Lift Station building

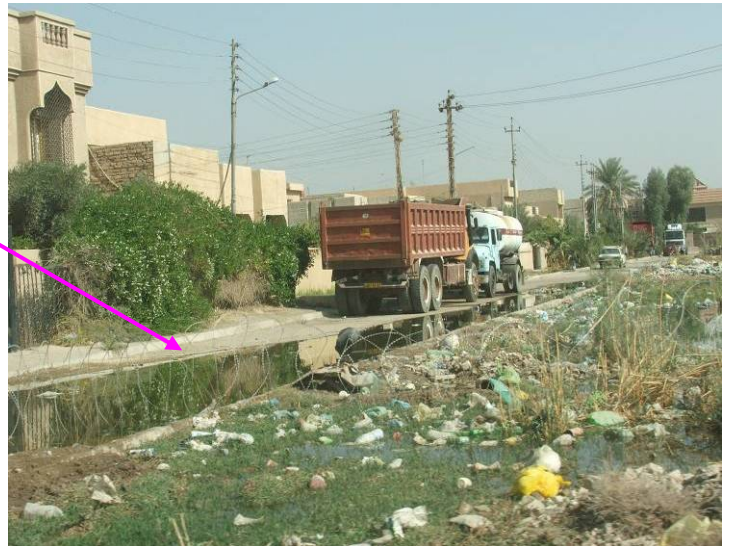
Site Photo 3. Backed-up sewer water

The degree of the streets' backed-up sewer water varied from several inches deep near the gutters to the entire width of the street.

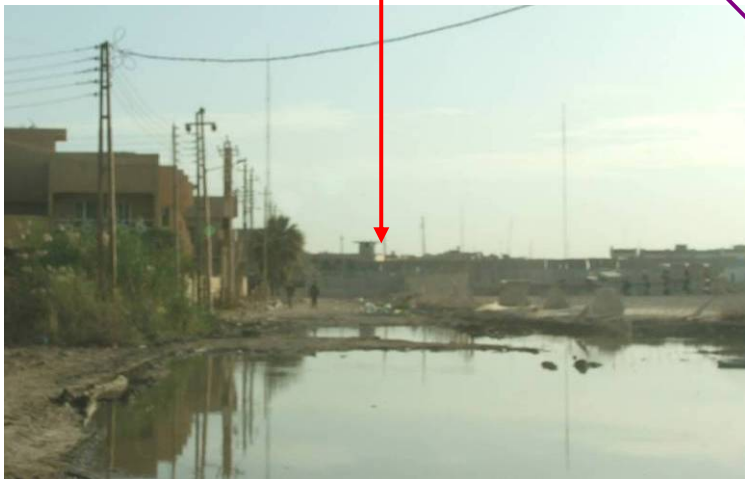
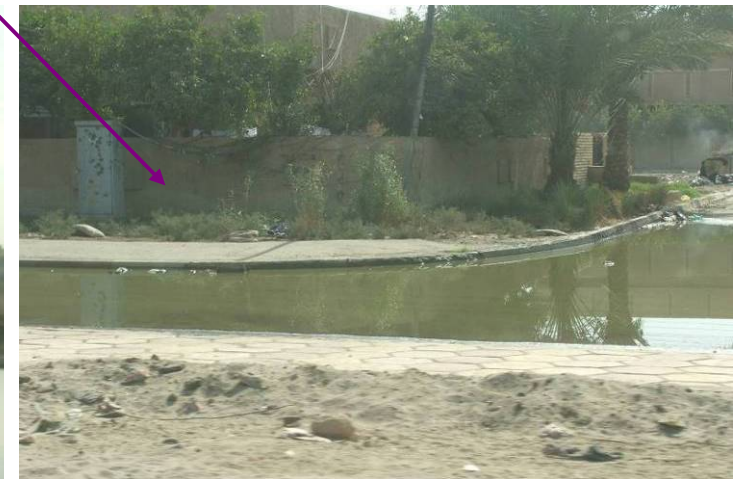
Site Photos 4 and 5. Backed-up sewer water in the Al Ghazaliyah area of Baghdad

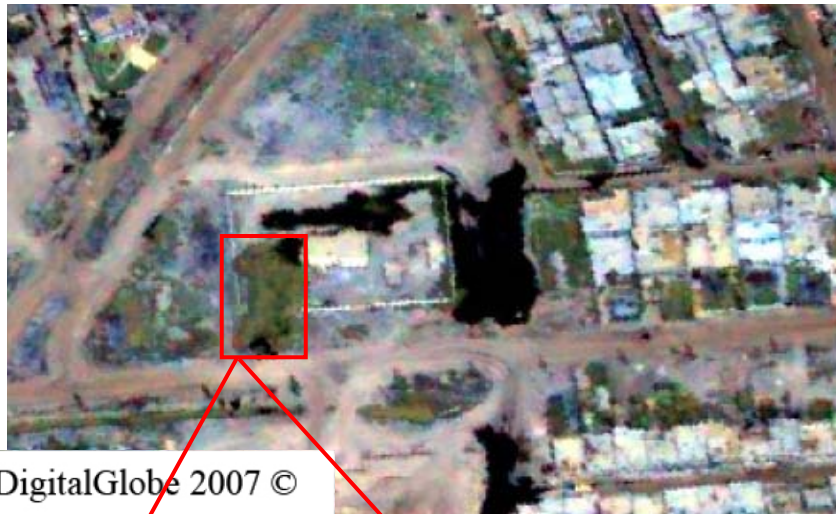
Inspectors also viewed a large pool of collected sewer water outside the sewage lift station building (Aerial Image 4 and Site Photos 6 and 7). During our site visit, maneuver unit personnel stated that the sewer pipes leading into the facility were old and broken. Considering the depth of the sewer water pool and the growth of weeds around it, the sewer line was broken for an extended period. However, the SOW did not address the problems with the broken sewer pipes. Without addressing this problem, the completion of this project will not lead to a "complete and useable facility" because the sewer water will not enter the lift station's wet well (to be pumped out to the next manhole).

Aerial Image 4. Aerial view of the Al Ghazaliyah G-7 Sewage Lift Station

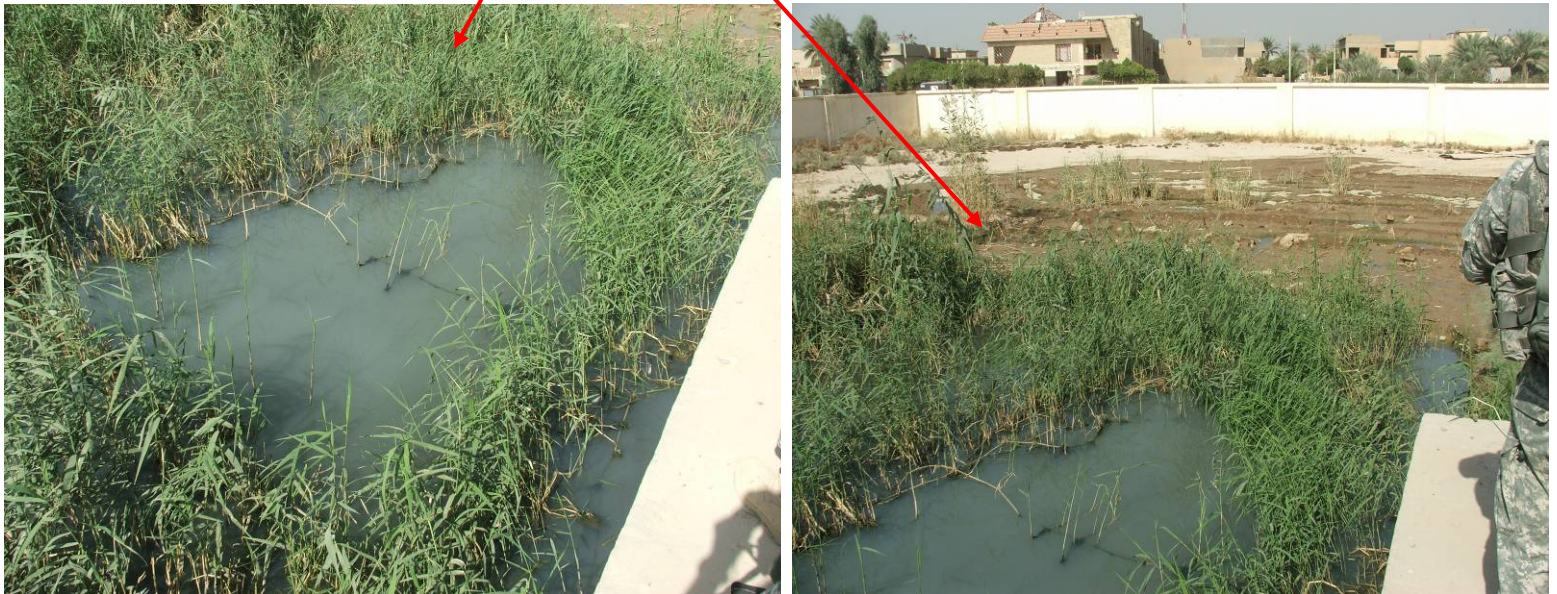
Site Photos 6 and 7. View of pool of accumulated sewage water outside the G-7 lift station

The use of the submersible pump inside the manhole appears to be a short term solution to deal with the large pool of sewer water outside the lift station building. Since the broken sewer pipe does not allow sewer water into the facility, the accumulation of sewer water grew each day. Installing the submersible pump into the wet well of the lift station would not help to alleviate the growing pool of sewer water outside.

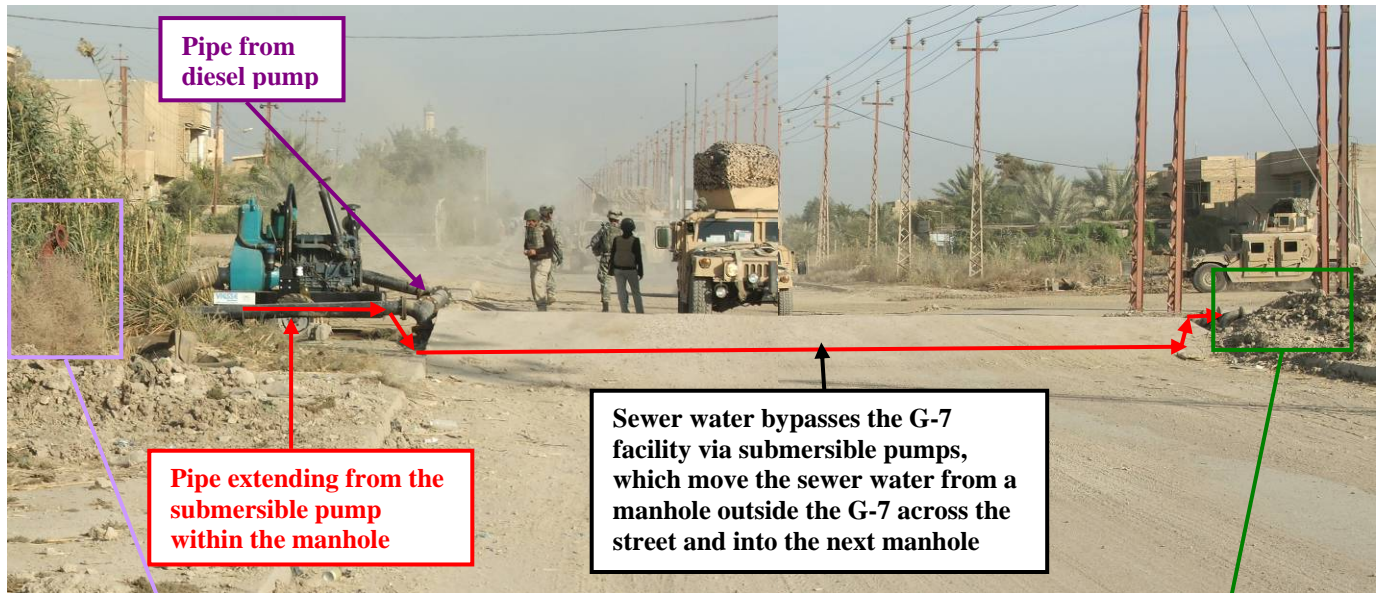
During our site visit, inspectors noticed two pipes exiting a manhole outside the lift station (Site Photo 8). One pipe was attached to an above ground diesel pump; while the other pipe was attached to a submersible pump. The two out-flow pipes rose out of an existing manhole and passed under a concrete hump to cross the street in order to use a higher elevation manhole as an outlet point (Site Photos 9 and 10).

Site Photo 8. View of bypass system employed to allow sewer water to flow to the next available manhole

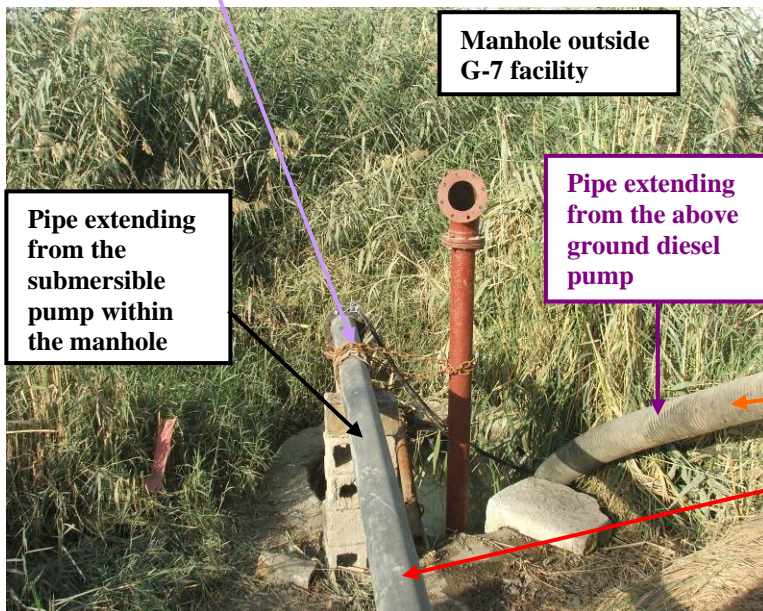
Site Photos 9 and 10. Enlarged views of Site Photo 8.

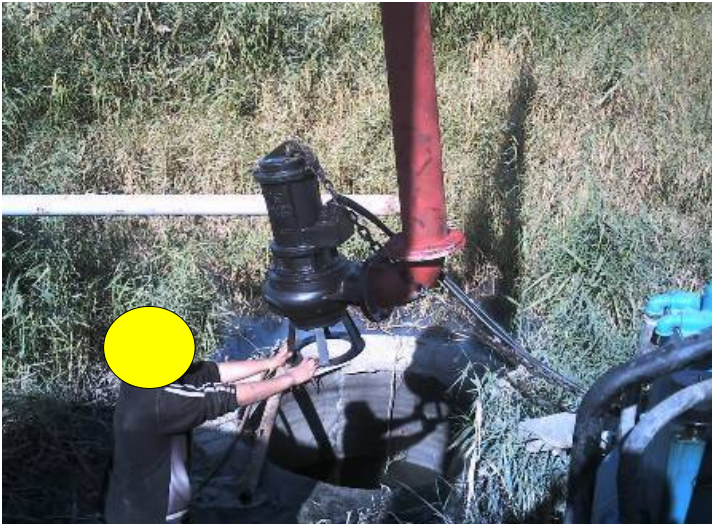
On 4 December 2006, the daily contractor's quality control (QC) report documented the delivery and installation of the single 150 mm submersible pump (Site Photo 11); while

Site Photo 11. Installation of 150 mm submersible pump into manhole outside G-7 lift station (Photo courtesy of USACE)

The contract file lacked documentation to explain the need for the submersible pump outside the lift station facility. As previously mentioned in the Project Design and Specifications section, the contractor did not provide design drawings to identify the use of the equipment required by the SOW. However, it appeared the original intent was to use the two submersible pumps either to replace or compliment the two existing submersible pumps inside the facility.

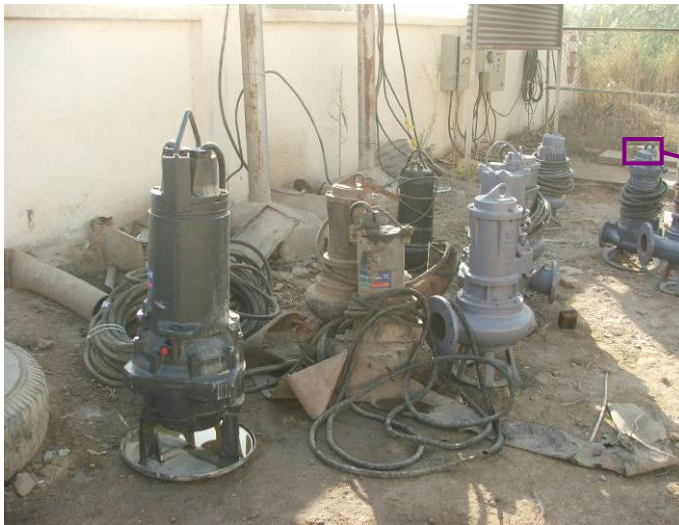
Site Photo 13. Submersible pumps located outside the G-7 lift station

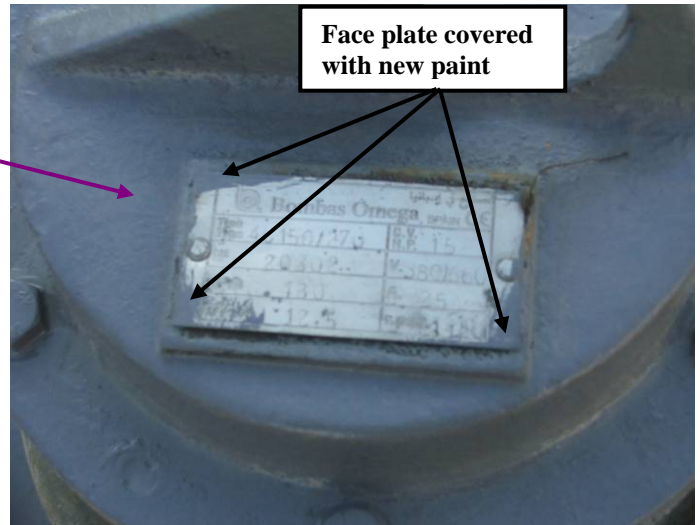
Site Photo 14. Close up view of a submersible pump (appears old pumps were just painted)

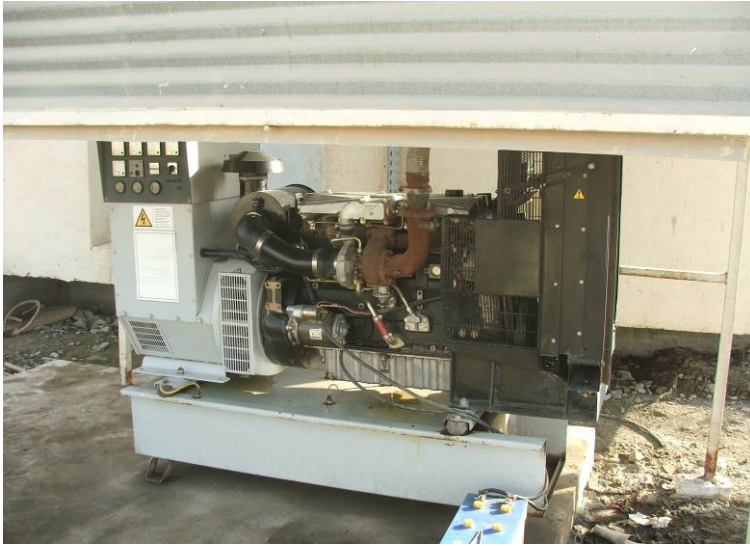
During our site visits, SIGIR identified two generators at the lift station site – one in front of the lift station and one in the rear. According to GRC documentation, the contractor supplied the generator in the rear of the facility (Site Photo 15). GRC personnel verified the contractor provided the contract required size generator (Site Photo 16). The generator was installed on a reinforced concrete pad, as required by the SOW.

Site Photo 15. Contractor provided 100 kVA generator

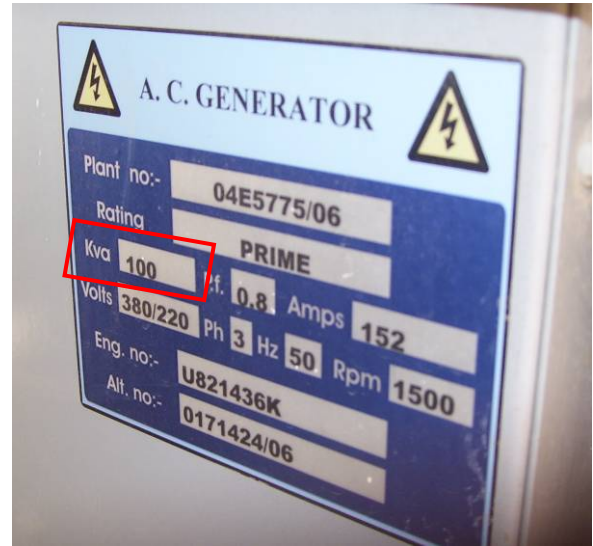
Site Photo 16. 100 kVA generator face plate

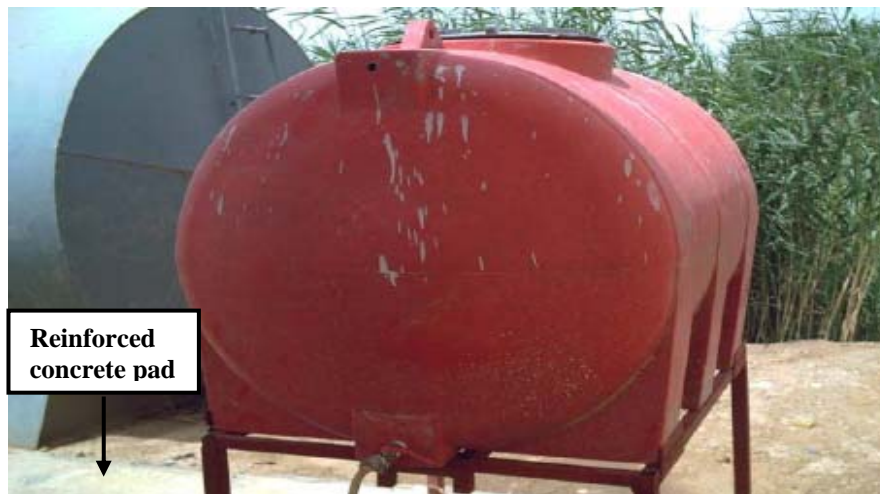
SIGIR identified two fuel tanks at the lift station. According to the daily QC reports, the smaller tank was the SOW required 1,000 liter fuel tank. The contract file lacked documentation to confirm this fuel tank is the required size. The fuel tank was installed on a reinforced concrete pad, as required by the SOW (Site Photo 17).

Site Photo 17. 1,000 liter generator fuel tank

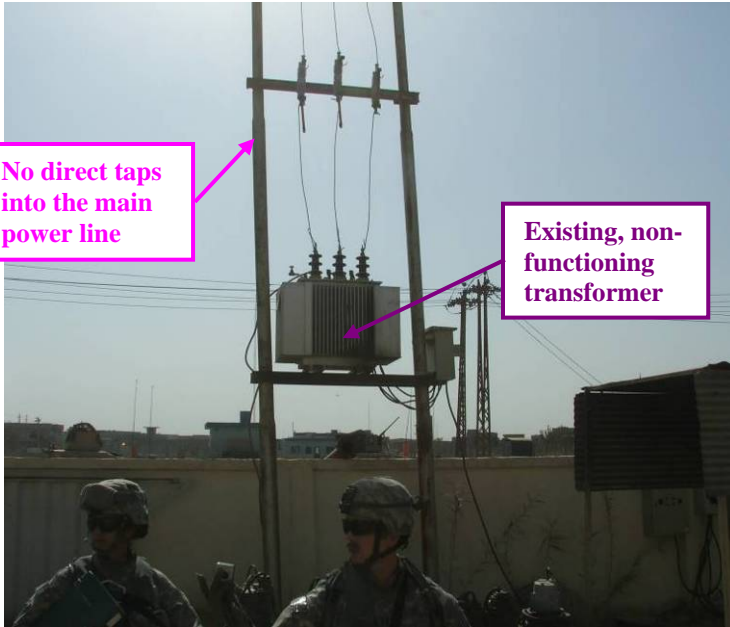
During our first site visit, SIGIR identified the old, non-operational transformer (Site Photo 18). The transformer was subsequently removed and the facility was directly tapped into the main power line by jury-rigging the electrical wires (Site Photo 19). This is an extremely dangerous practice and likely will damage and/or destroy the facility's electrical equipment and controls as well as endanger the safety of the operator. Iraqi main power lines normally carry 400 volts. Without a step-down transformer, turning on the control panel could potentially short circuit the equipment and potentially electrocute

Site Photo 18. Existing transformer

The lift station requires a new transformer to take advantage of the electrical grid and also the two on site generators.

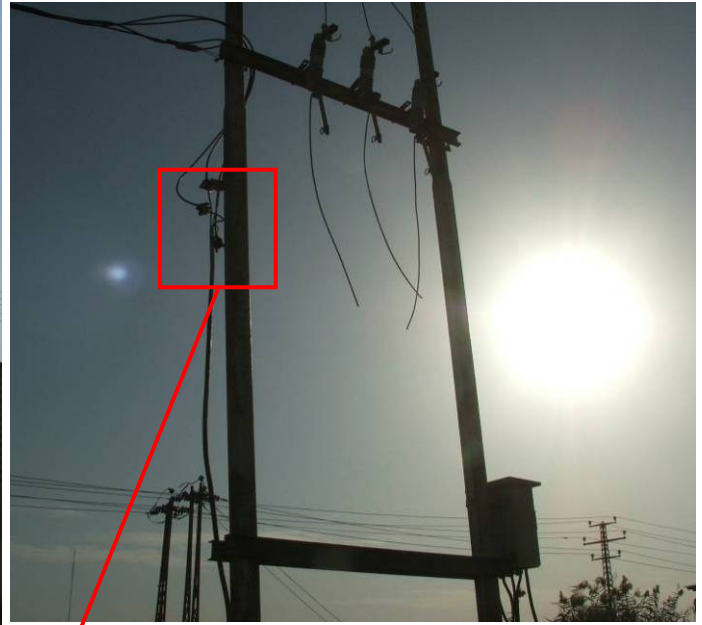
Site Photo 19. Missing transformer and direct tapping into the main power line

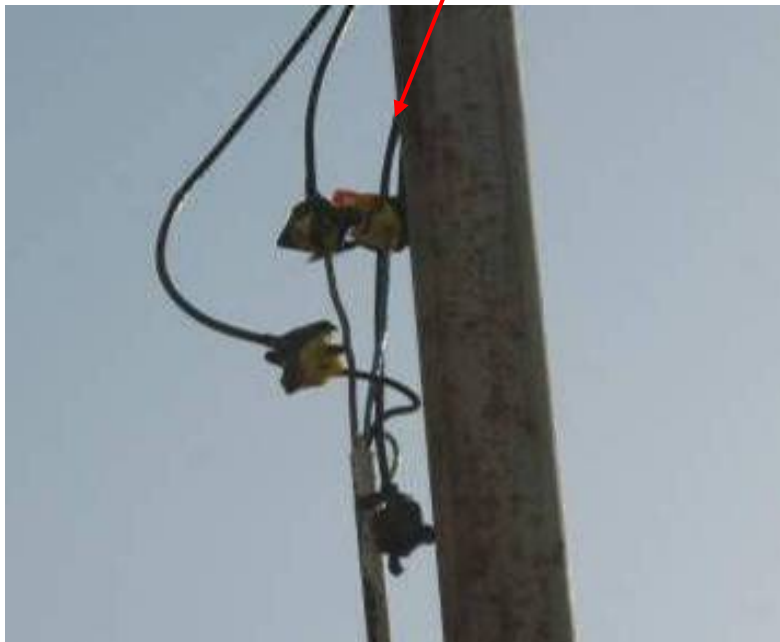
the operator. It is extremely unsafe to have unregulated splices in power cables carrying relatively high voltage since the splices are unsupported and unprotected (Site Photo 20). As a result, it is possible that a loose wire could come free and potentially electrocute someone in the vicinity of the lift station.

Site Photo 20. Unsafe splices directly into the main power line

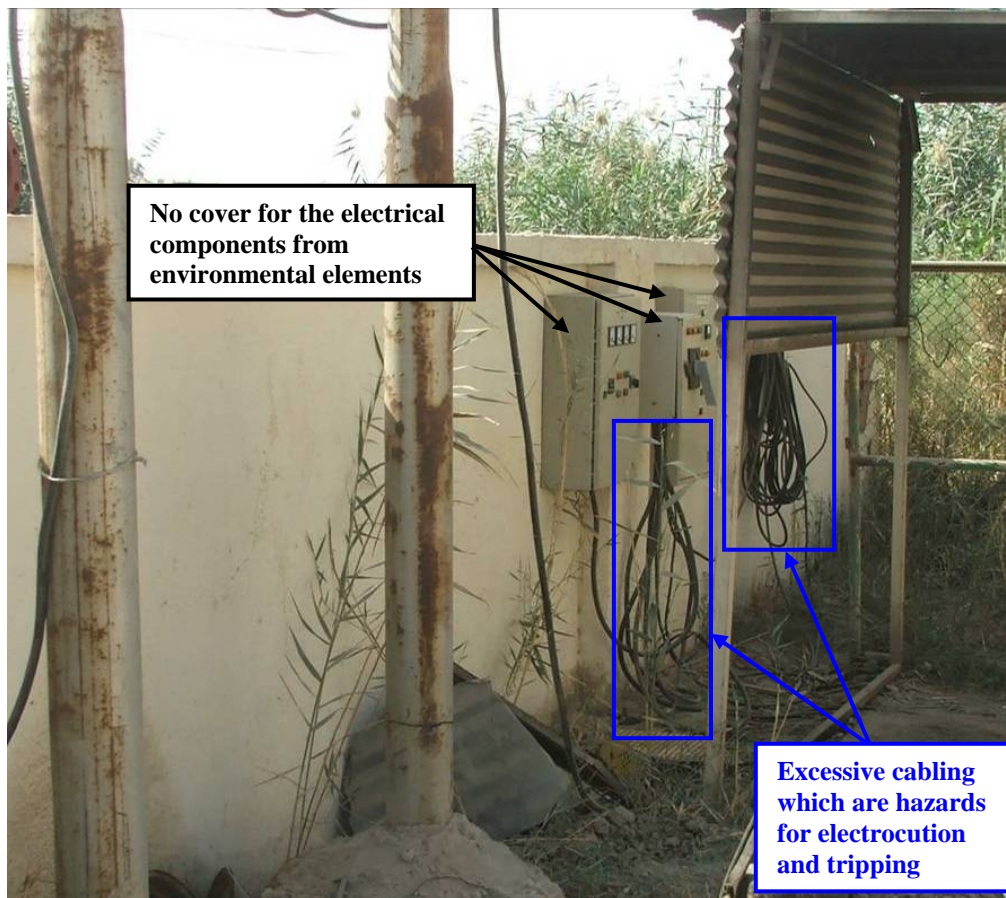
SIGIR identified the Main Distribution Panel and the cabling supplied and installed by the contractor to connect the facility to the main distribution grid (Site Photo 21). The installation technique used by the contractor was not adequate. For example, the contractor situated the control panel outside the facility without any method to protect the electrical components from the environmental elements, such as rain, excessive heat, sand, and dirt, which over time, will reduce the lifespan and usefulness of the control panel. In addition, an excessive amount of cabling was used, which resulted in electrical cable dangling down on the ground. The dangling cabling poses not only a tripping hazard, but could become damaged and also lead to electrocution.

In view of the previously noted fact that the electrical control panels were improperly directly tapped from the main distribution grid and without use of a step-down transformer, inspectors did not feel it was safe to touch the electrical control panels. As a result, we could not assess the quality of the contractor's performance.

Site Photo 21. Main Distribution Panel for the G-7 lift station
